Cutting Corners and Unsafe Practices, a recipe for disaster

SAFETY POLICY

Safety Feedback

Landing Gear Failed to Retract

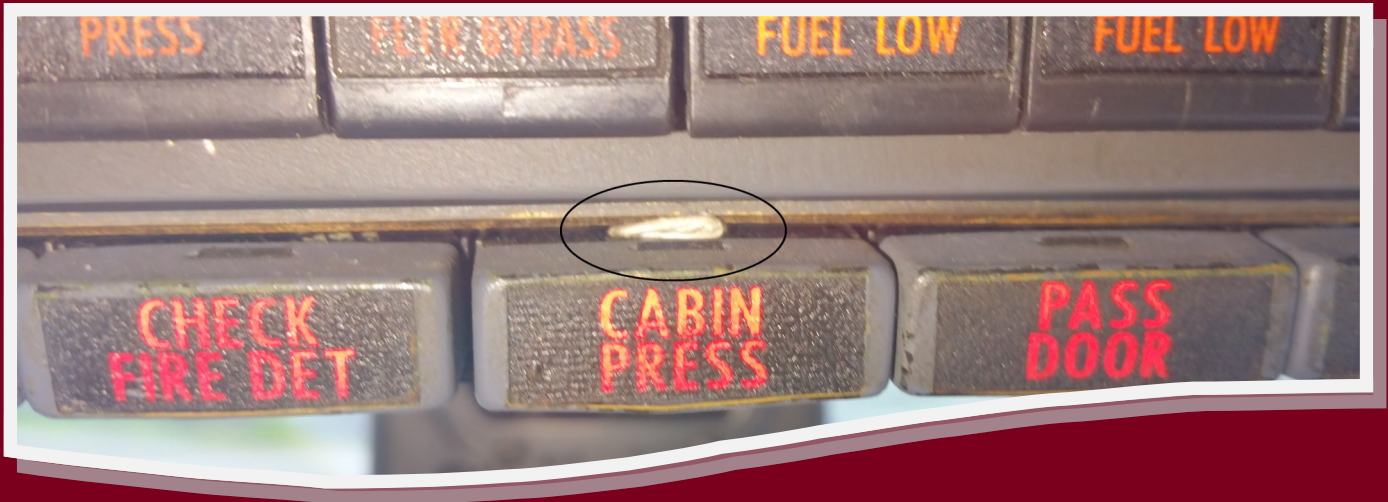
Inspection carried out by Aircraft Maintenance noted a lens filter on the master caution annunciator panel was loose.

Closer inspections, revealed a piece of paper was jammed (as shown in photo above) to stop the Cabin Press caution/warning light from falling out from the annunciator

A new lens filter was fitted and operational checks carried out satisfactorily in-accordance with relevant Aircraft Maintenance Manual (AMM). The aircraft was then released

The aforementioned practices resulted in a Quality Alert Notice # 05/16, issued by the Quality Control Section of Aircraft Maintenance Department, advising all maintenance personnel that jamming panels with paper is an improper practice and will not be tolerated

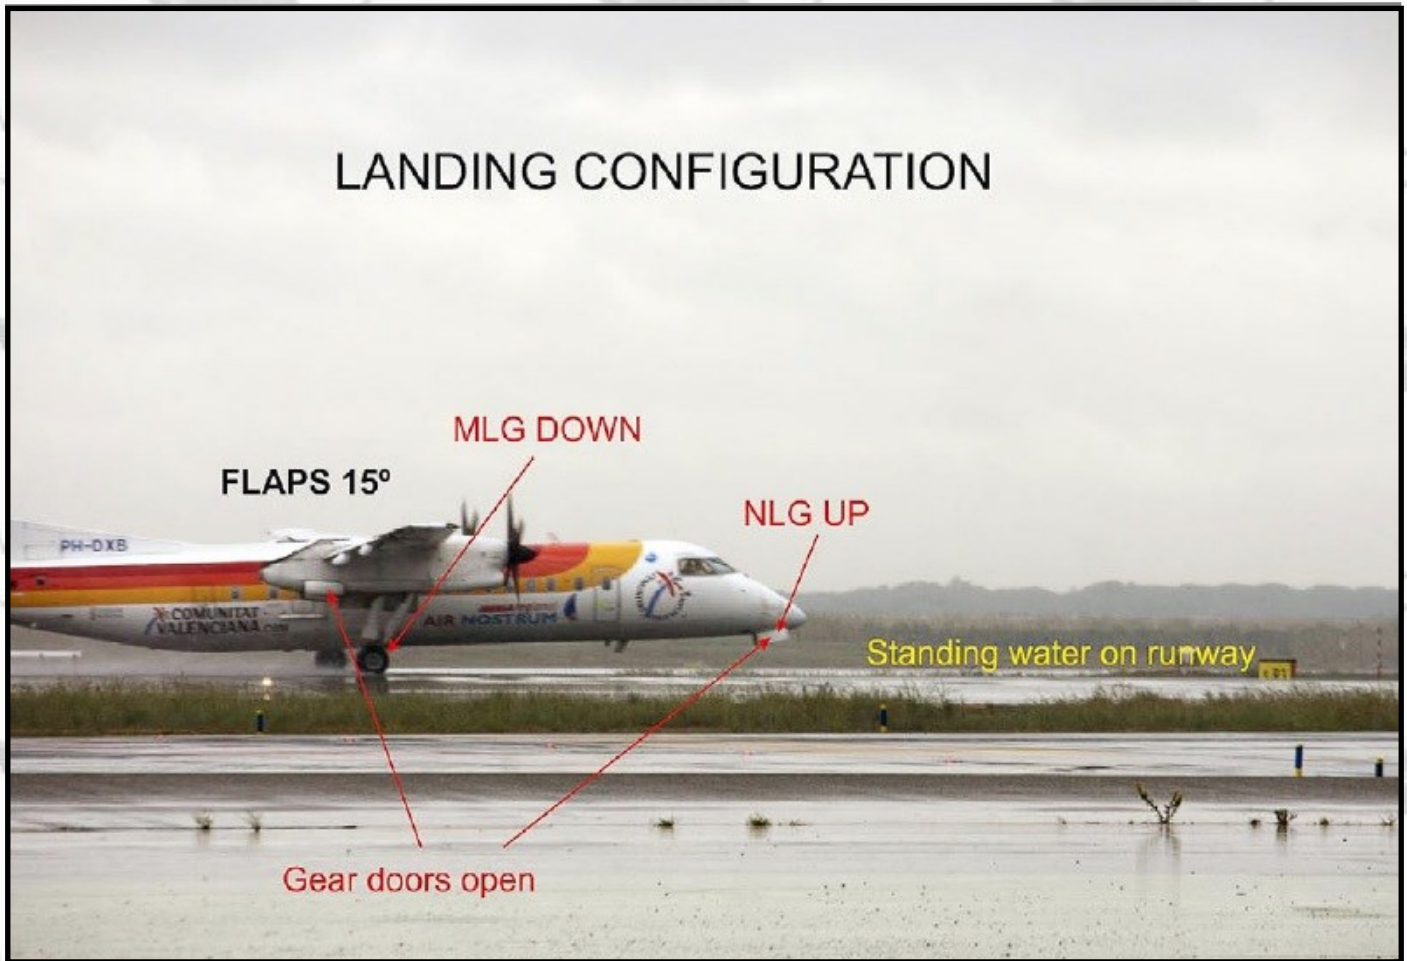
"The cause of the incident was the improper operation of the landing gear system by the crew that due to both a lack of knowledge of said system and to deficiencies in the use of the available procedures, was unable to identify or correct the abnormal configuration of the Landing Gear Alternate Release Door.

Photograph of the airplane during incident touchdown

continued by selecting the gear lever down, which resulted in both main gear showing green, the nose gear red, three amber lights because of open gear doors also illuminated. The crew declared emergency and advised the flight attendant who in turn informed the passengers. The approach was continued for a landing on runway 25R without nose gear about 21 minutes after departure.

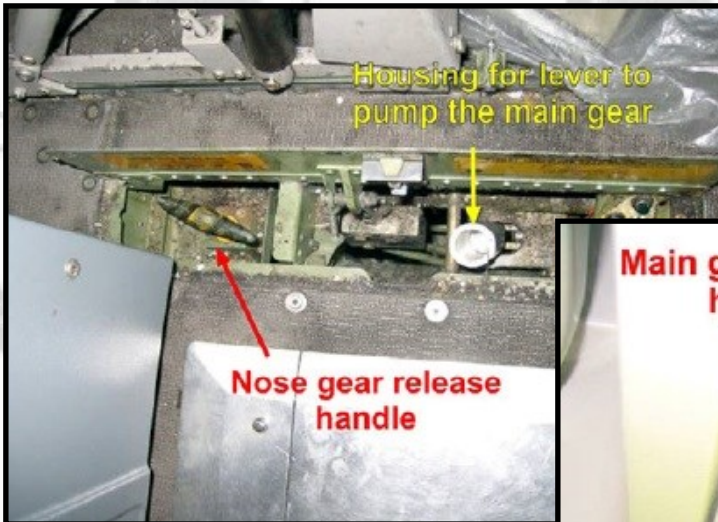
The CIAIAC analysed: "The 'Landing Gear Alternate Release Door', located in the overhead in the cockpit, was probably partially open when the crew reported to the airplane, but if so, this was not detected either by the CPT during her check of the cockpit or subsequently by either pilot at any time prior to take-off. The airplane thus took off with this condition uncorrected." This resulted in all three gear legs not retracting upon the gear being selected up.

Top: Floor Door

Right: Overhead Door

the landing gear. Had a procedure been available to the crew that included a check of the position of this door, the crew could have quickly ascertained its abnormal position, corrected it and retracted the gear, allowing them to continue with the flight normally." Another operator however had identified the issue and adjusted their procedures to have the crew verify the overhead door before continuing with other procedures. The CIAIAC therefore recommended to de Havilland/Bombardier and the operator to adjust their procedures accordingly.
